DEPARTMENT OF NATURAL RESOURCES

Environmental **E**mergency **R**esponse

Belle Fountain Ditch Glycerin Release

Inspection Process

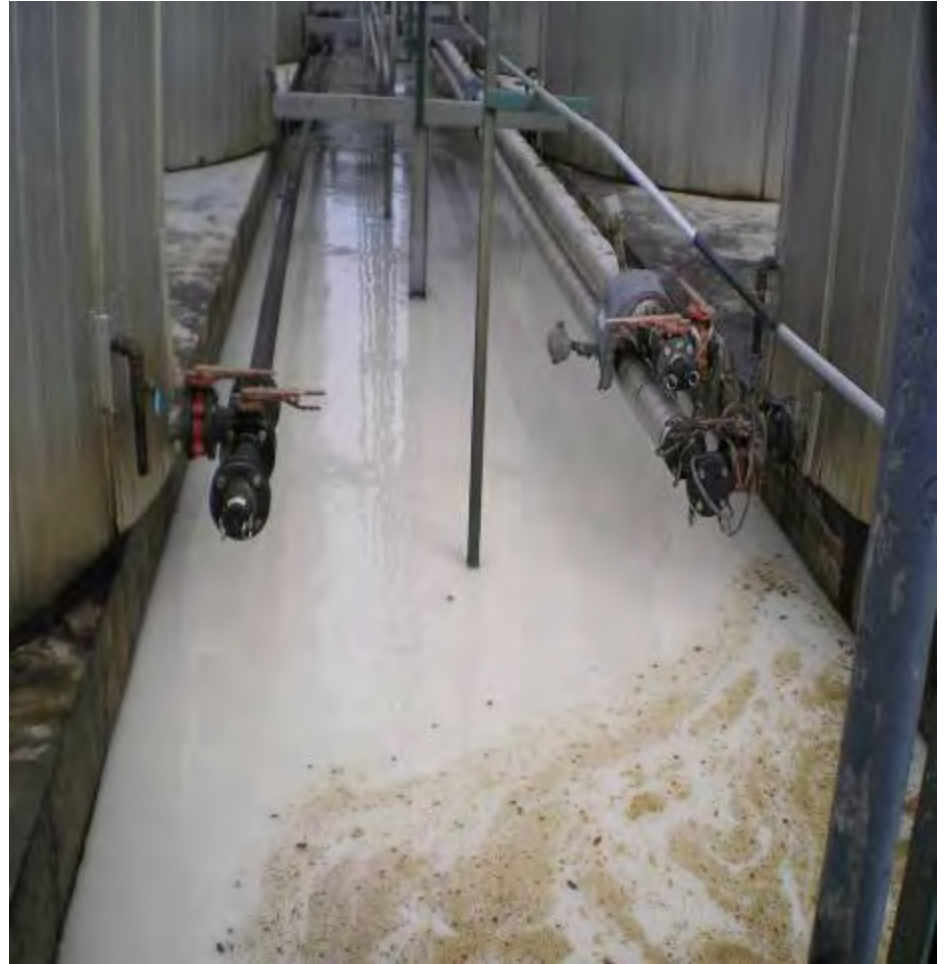
- ❑ Shoddy construction and questionable materials used.
- ❑ Tank insulation material is highly absorbent.
- ❑ Tanks sit on a gasket that would dissolve once it comes in contact with product and leave an oily sheen during rain events.

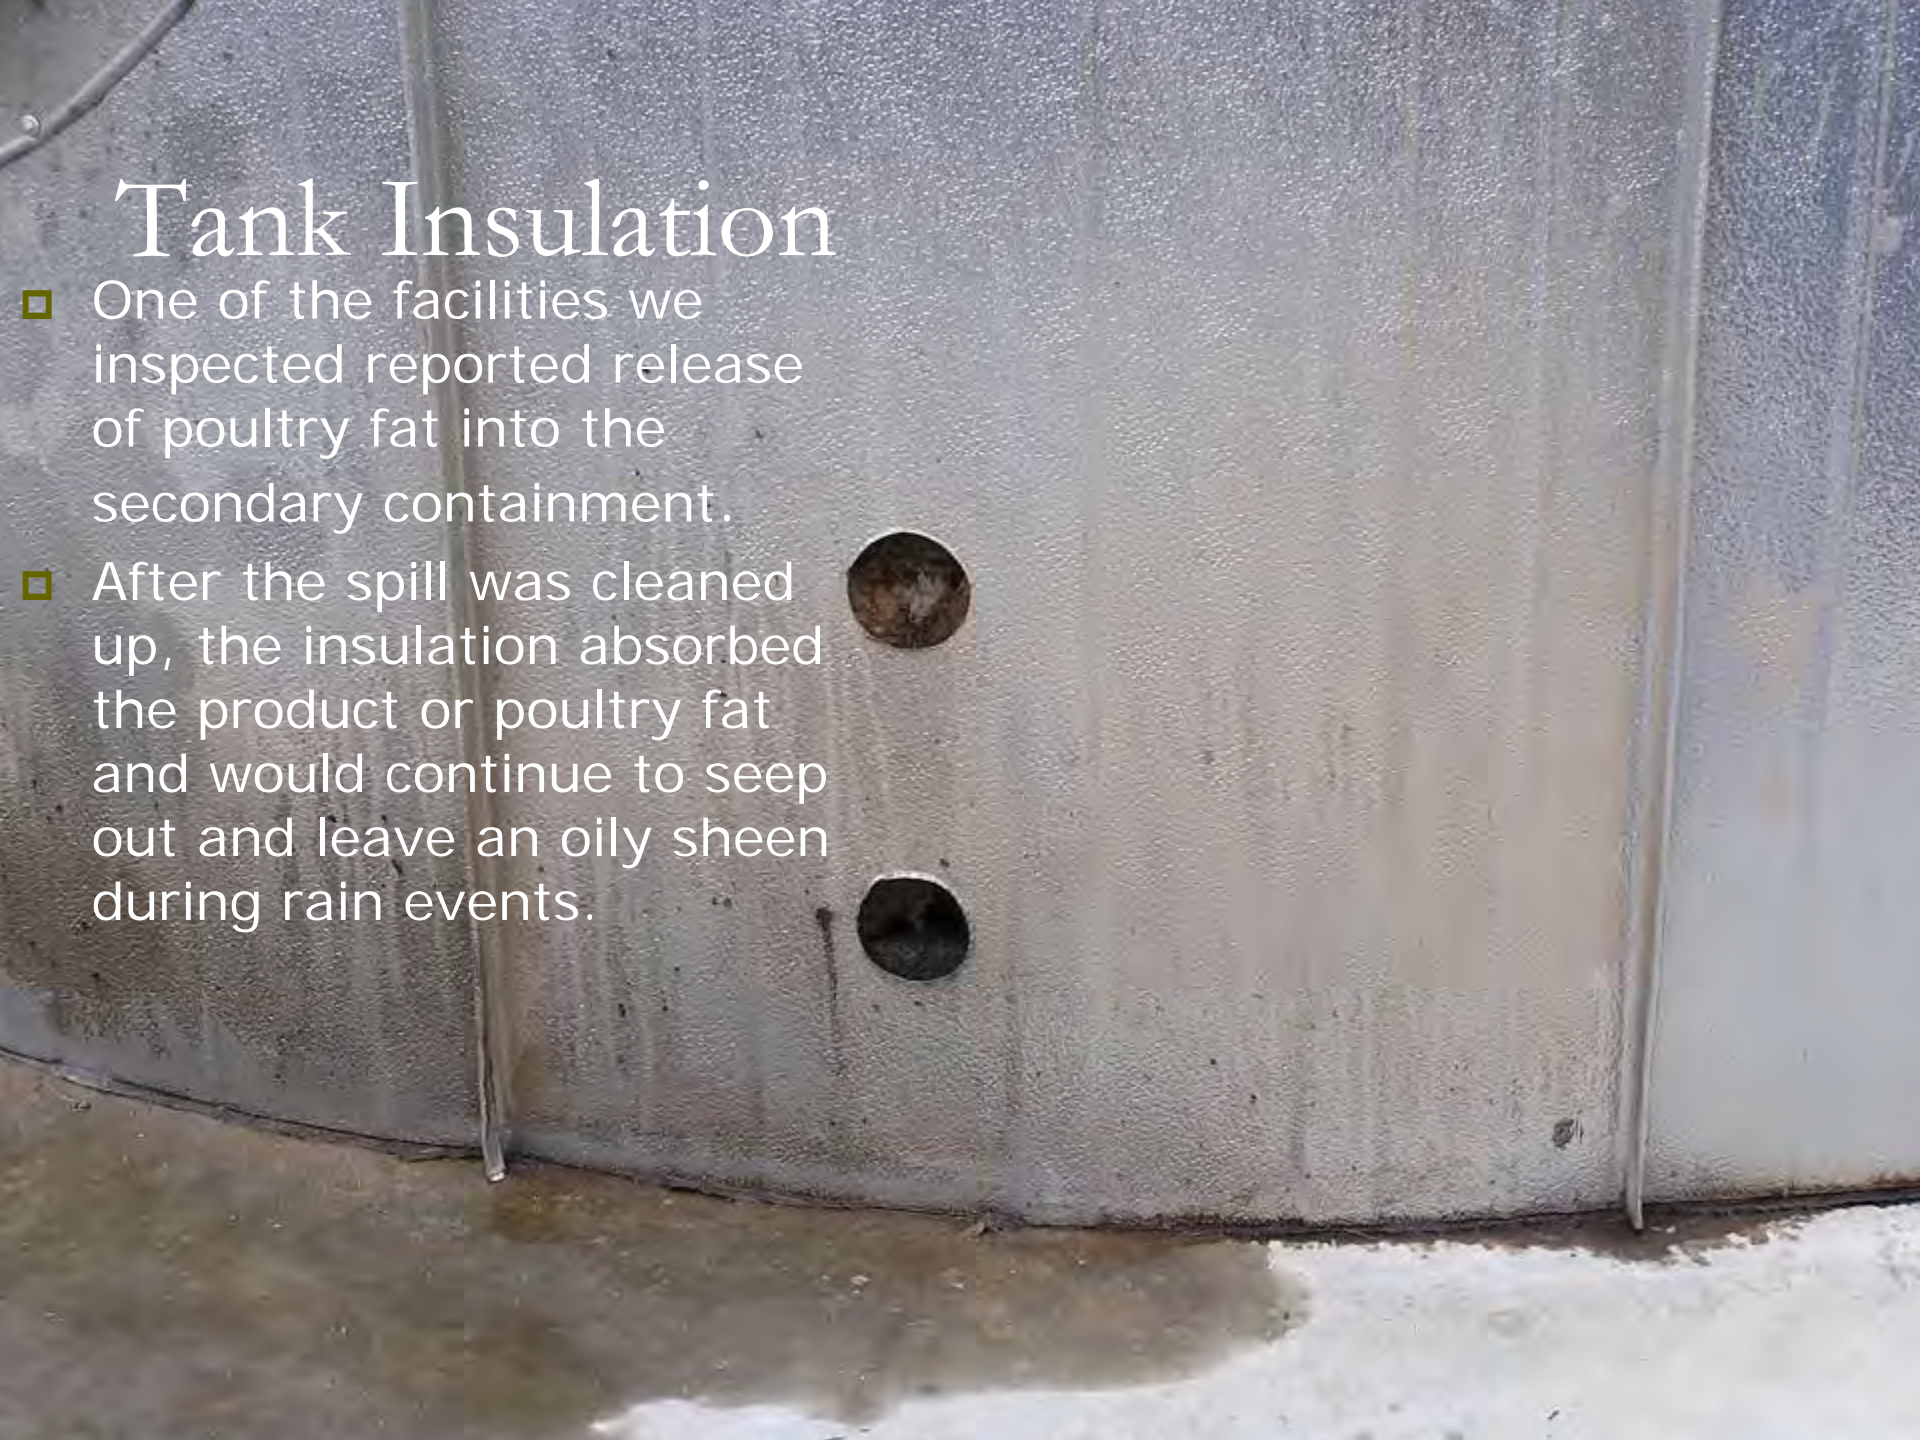
Tank Insulation

- One of the facilities we inspected reported release of poultry fat into the secondary containment.
- After the spill was cleaned up, the insulation absorbed the product or poultry fat and would continue to seep out and leave an oily sheen during rain events.

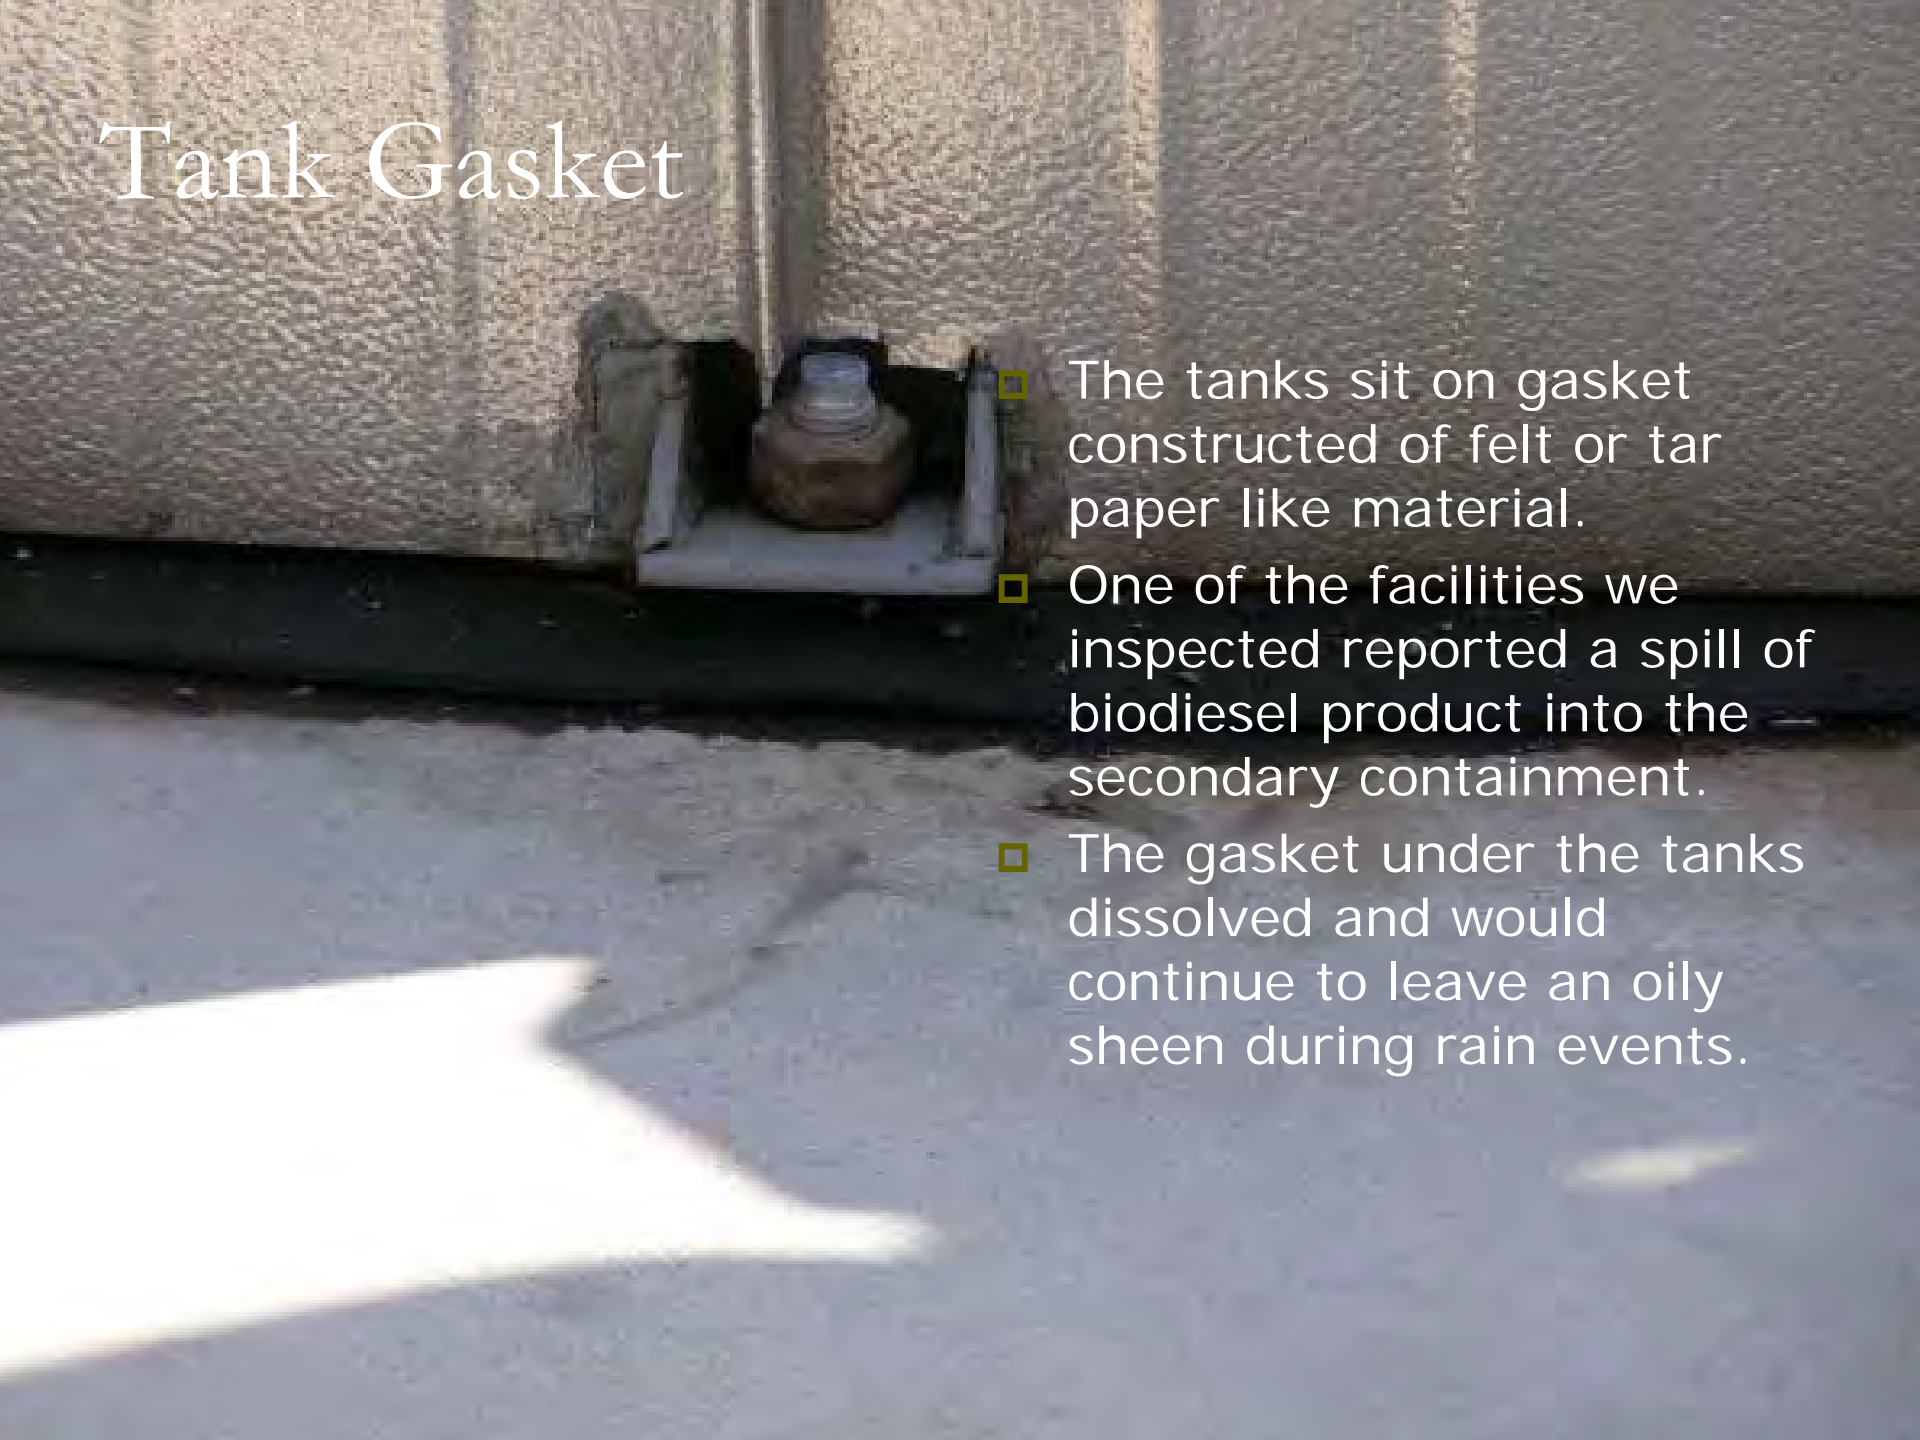
Tank Gasket

- The tanks sit on gasket constructed of felt or tar paper like material.
 - One of the facilities we inspected reported a spill of biodiesel product into the secondary containment.
 - The gasket under the tanks dissolved and would continue to leave an oily sheen during rain events.

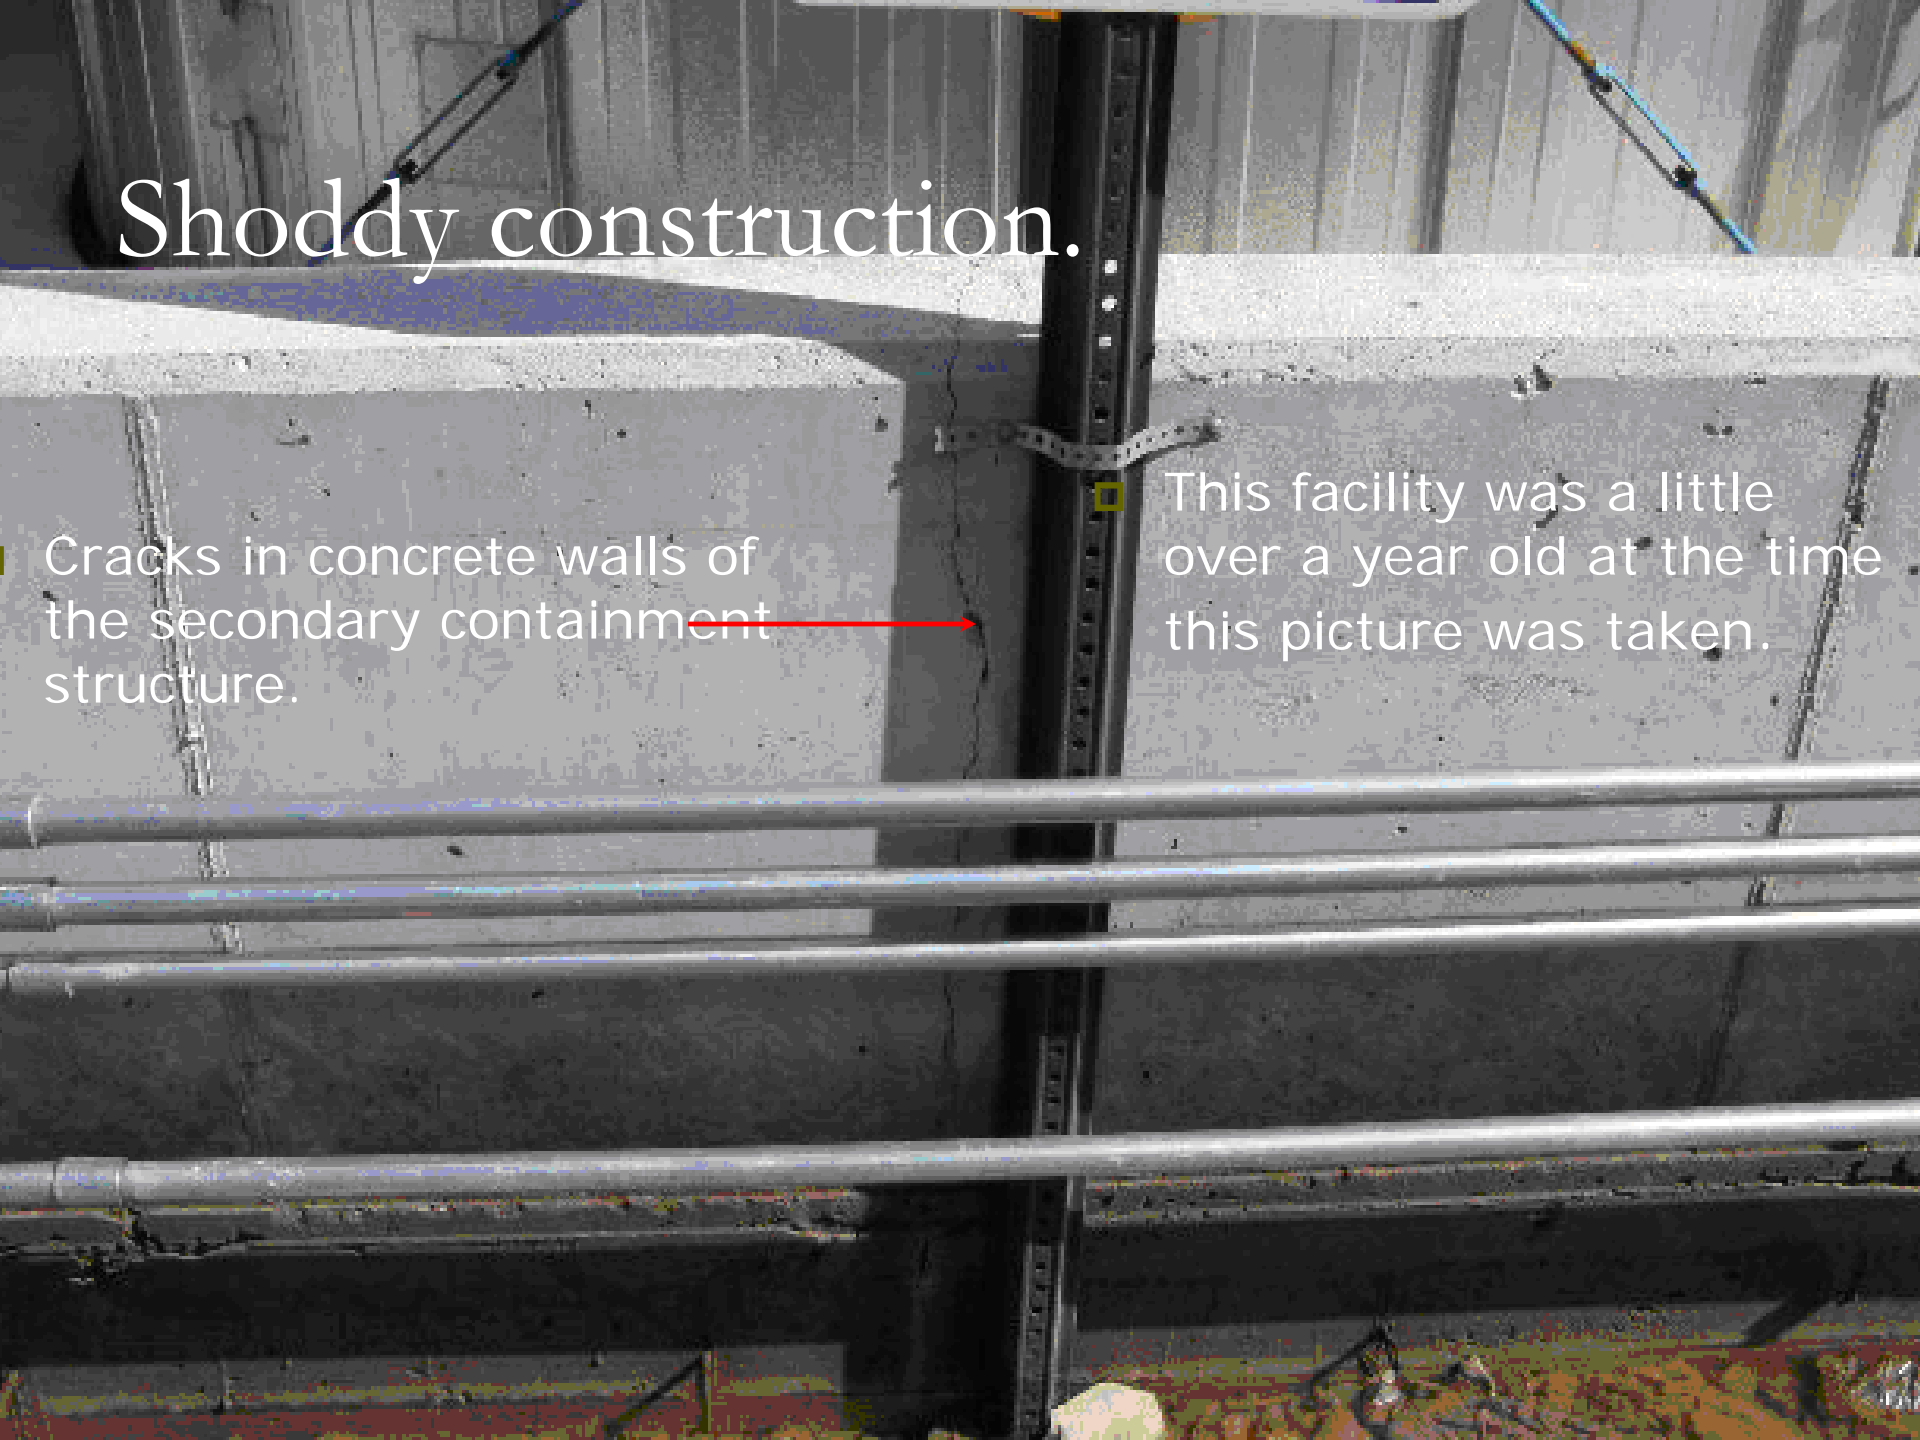
Shoddy construction.

Cracks in concrete walls of the secondary containment structure.

■ This facility was a little over a year old at the time this picture was taken.

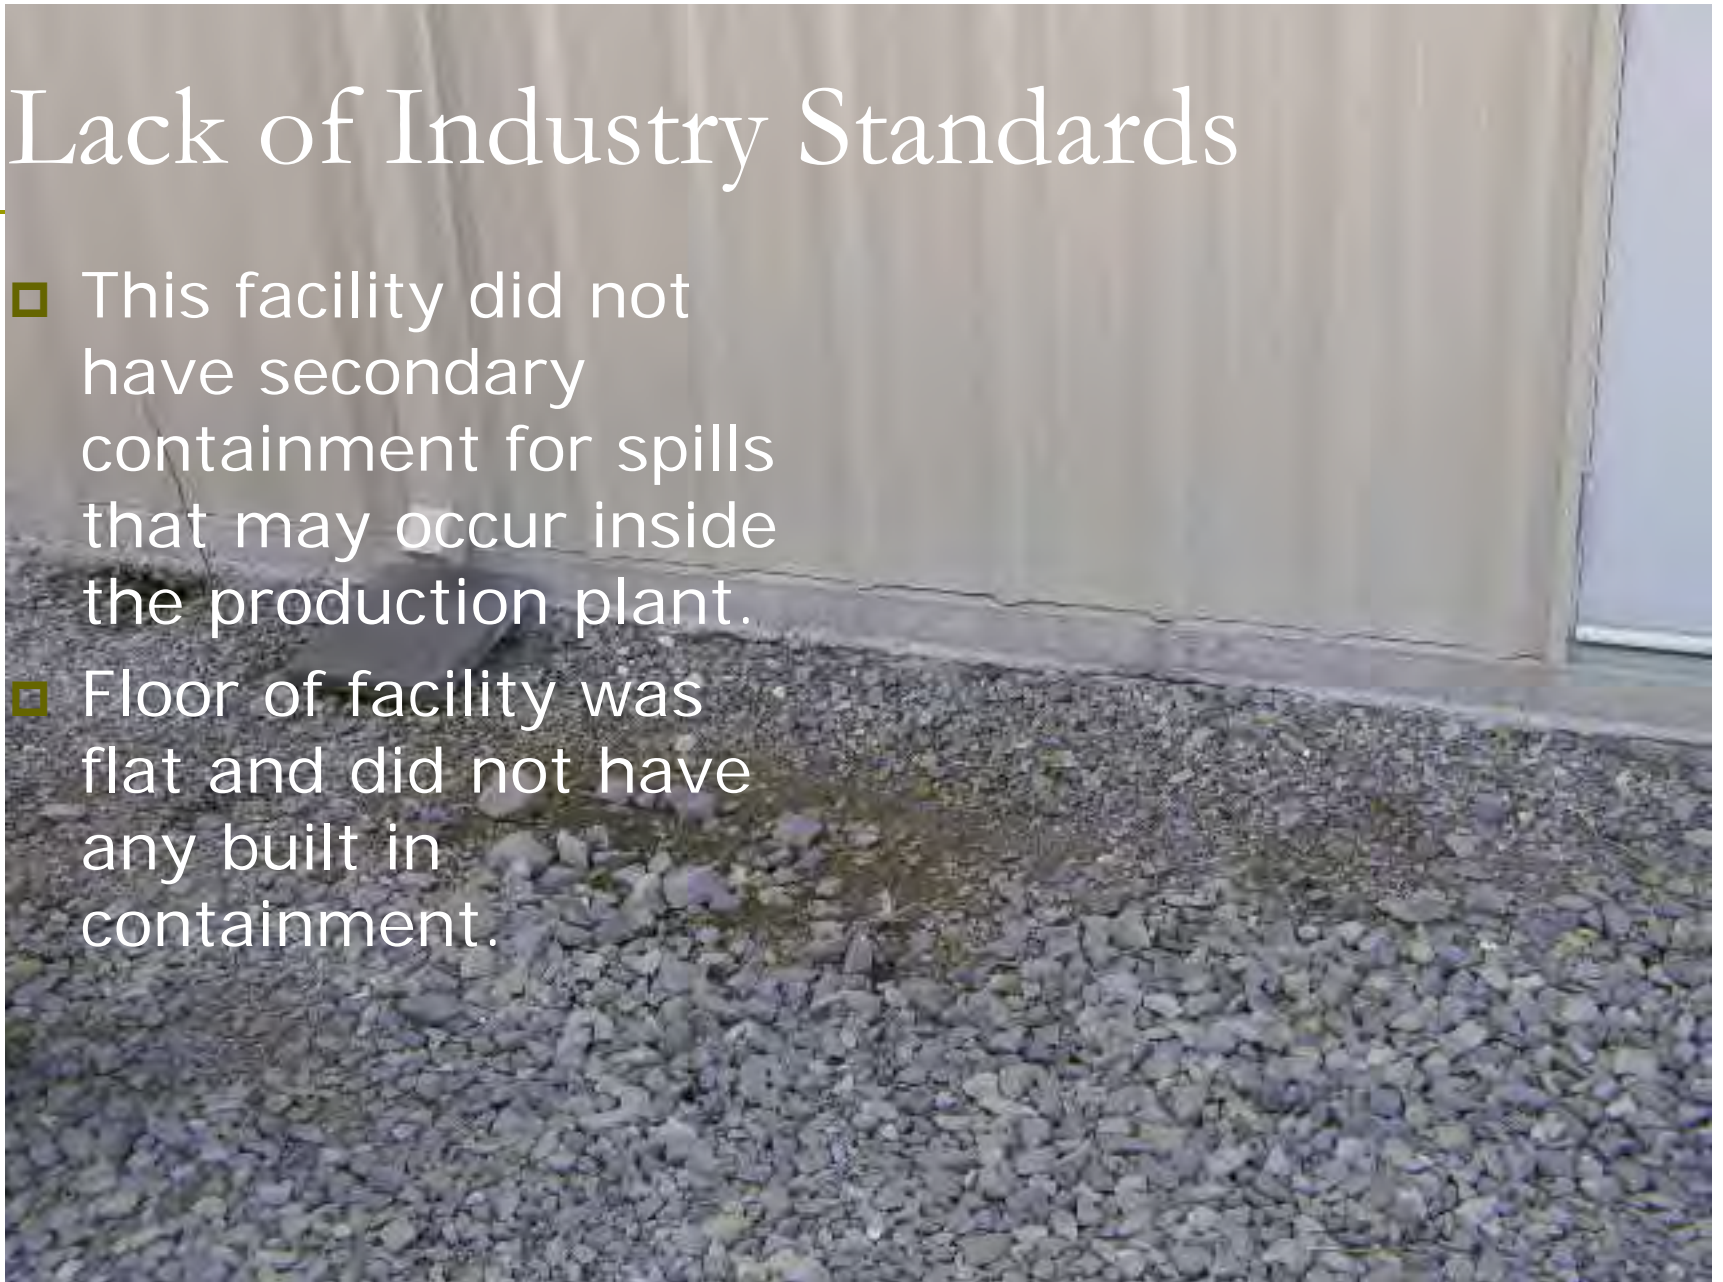
Lack of Industry Standards

- This facility did not have secondary containment for spills that may occur inside the production plant.
- Floor of facility was flat and did not have any built in containment.

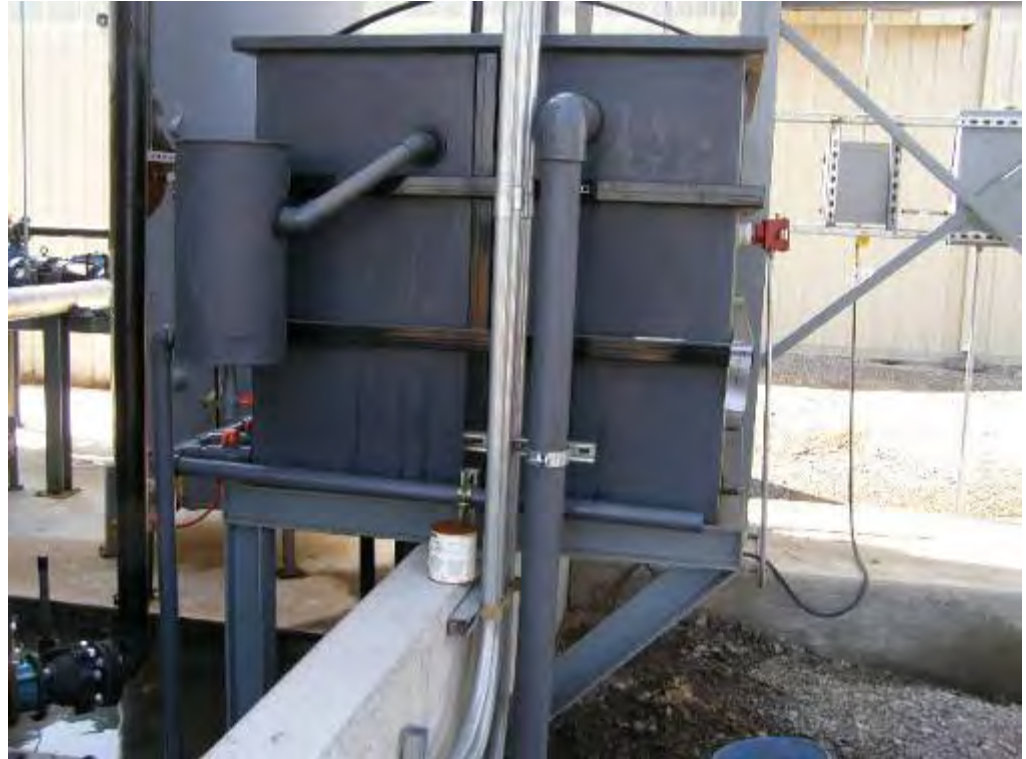
Faulty equipment & design.

- ❑ Two of the facilities reported problems with the oil & water separators.
- ❑ Facilities claimed that the equipment was faulty and not effective in removing oil and product from the storm water.
